April 17, 1998

GFK-1397E

IMPORTANT PRODUCT INFORMATION

Product: CIMPLICITY® Control, Version 2.1

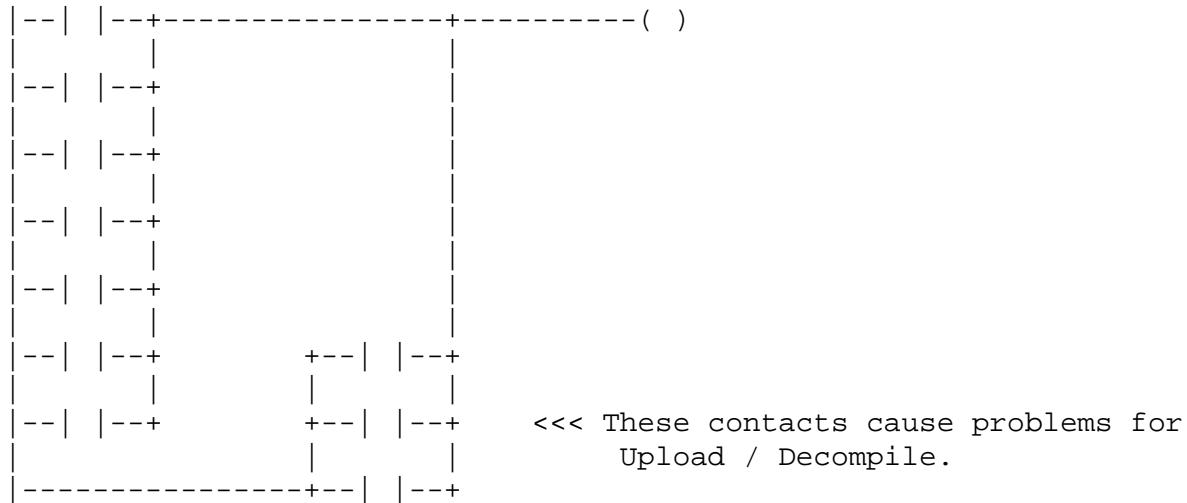
4. **Rungs of the following form in 90-30 folders will no longer cause CIMPPLICITY Control to crash on Load from PLC.** Rungs that logically attempt to get more than 8 deep OR branches no longer cause CIMPPLICITY Control to crash on a Load. These rungs are illegal rungs for 90-30 LD that are not flagged as illegal during Save and Compile.

The decompiler will now place entries in the log file whenever rungs of this type are encountered on a load. These rungs still must be manually corrected in order for a load to correctly work.

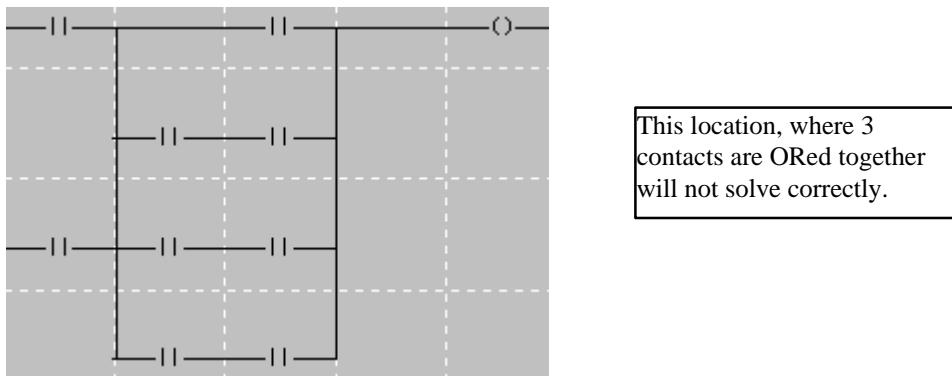
1. **Incorrect Logic Solution:** Version 2.0 Service Pack 3 and Version 2.01 corrects a problem with logic solution in Series 90-30s using CIMPPLICITY Control. RLD programs with the following construction will not solve correctly if stored with Version 2.0. Refer to Field Service Bulletin M-04-98-01 "CIMPPLICITY Control Release 2.0 Safety Alert" for more information.

To fix this problem, install Version 2.01 and then do a Rebuild All of each CIMPPLICITY Control Series 90-30 folder.

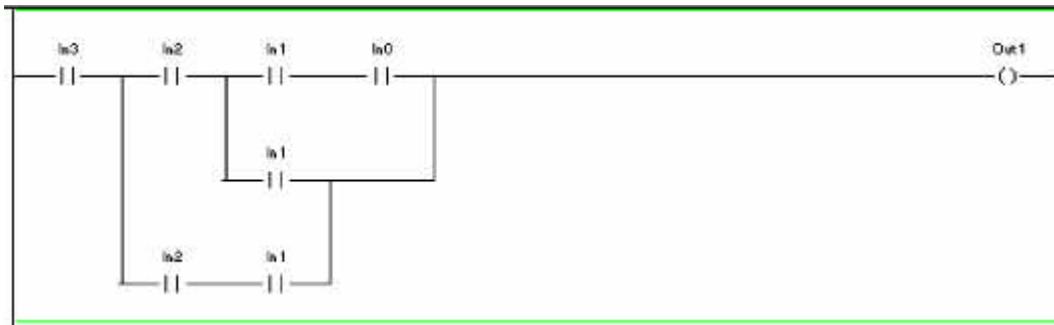
2. **Parameter Edit dialog box.** The Parameter Edit dialog box allows 64 characters for the description field, but will display only 57 characters from the Header dialog box.
3. **Seventy or more transitional contacts in same rung.** If using 70 to 80 transition contacts in the same rung in Accept or Normalize mode, premature termination of CIMPACTY Control may occur which will cause you to lose changes since your last Save.
4. **Deleting all instructions in a rung does not delete the rung.** To delete a rung, you must select the rung by clicking to the left of the power rail and then delete the rung.
5. **Complex 90-30 Boolean rungs failing on compile.** Some 90-30 complex boolean rungs, such as the one in the following example, fail on compile. The error message “Logic sub-path cannot enter in the middle of another sub-path” is generated.
