IMPORTANT PRODUCT INFORMATION

Product: Programmable Controller CPU Module
IC697CPU781-HB
IC697CPU782-HB

This is the production release of the IC697 PLC CPU modules version 5.50. The purpose of this release is to support the Plug & Play VME PC, the IC697 High Speed Counter module, other new features described under New Features and Functionality, and to fix the problems listed under Problems Resolved by This Upgrade.

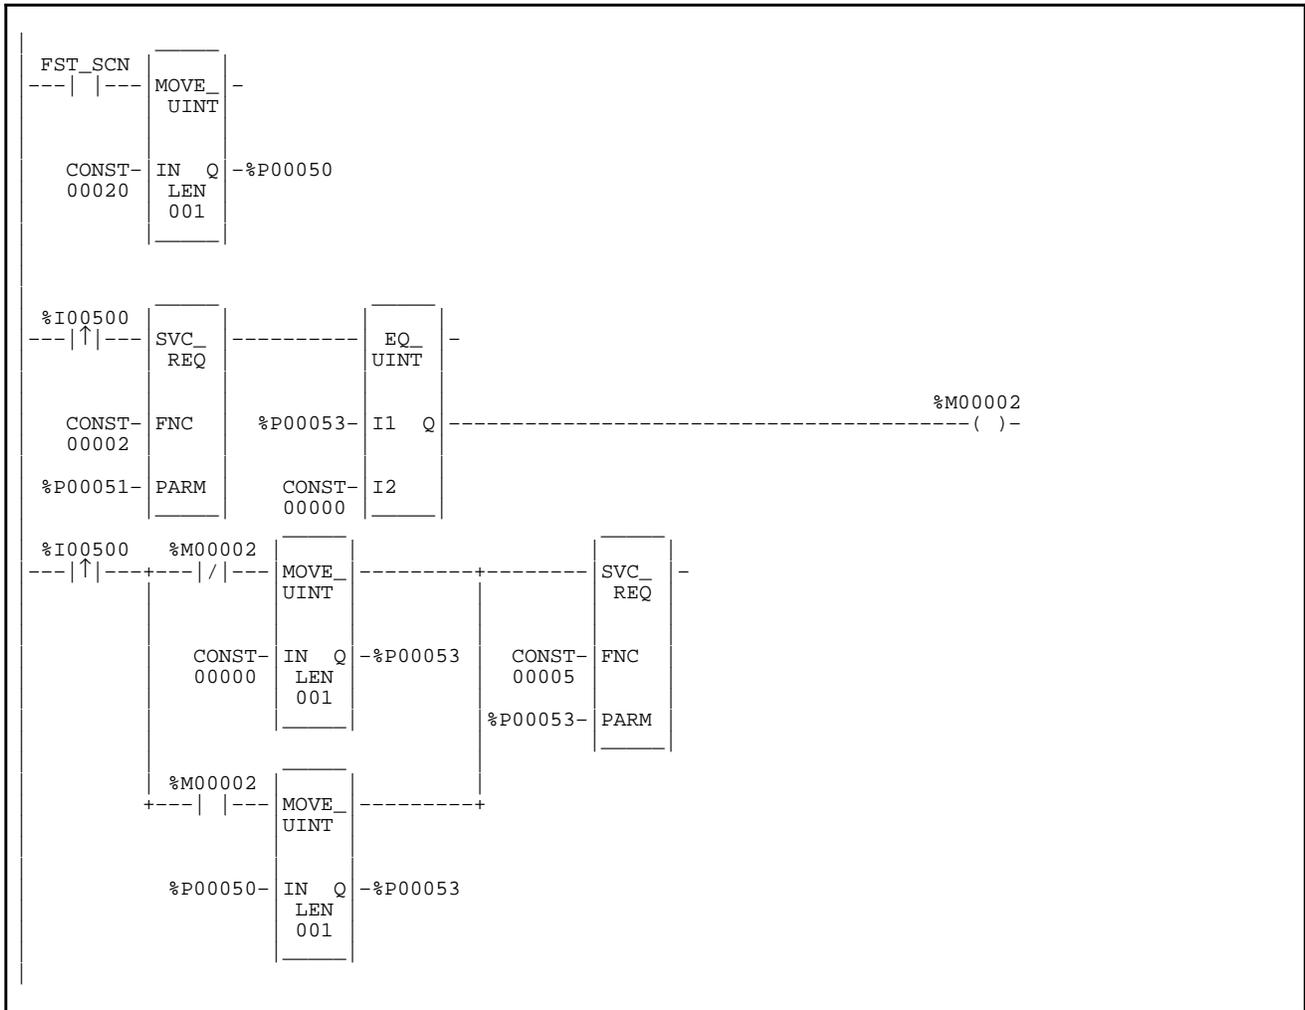
Example:

In the following example, when enabling contact FST_SCN is set in the first scan, the MOVE function establishes a default value of 20 ms for the background task window, using a parameter block beginning at %P00050. Later in the program when input %I00500 transitions on, the state of the background task window toggles on and off. The parameter block for all three windows is at location %P00051. Since the time for the background task window is the third value in the parameter block returned from the Read Window Values function (function #2), the location of the existing window time for the system communications window is %P00053.
